Title: Electrorefining Low Yield Possible Root Causes

Author(s): Ewing, Frederic

Electrorefining Low Yield

Possible Root Causes

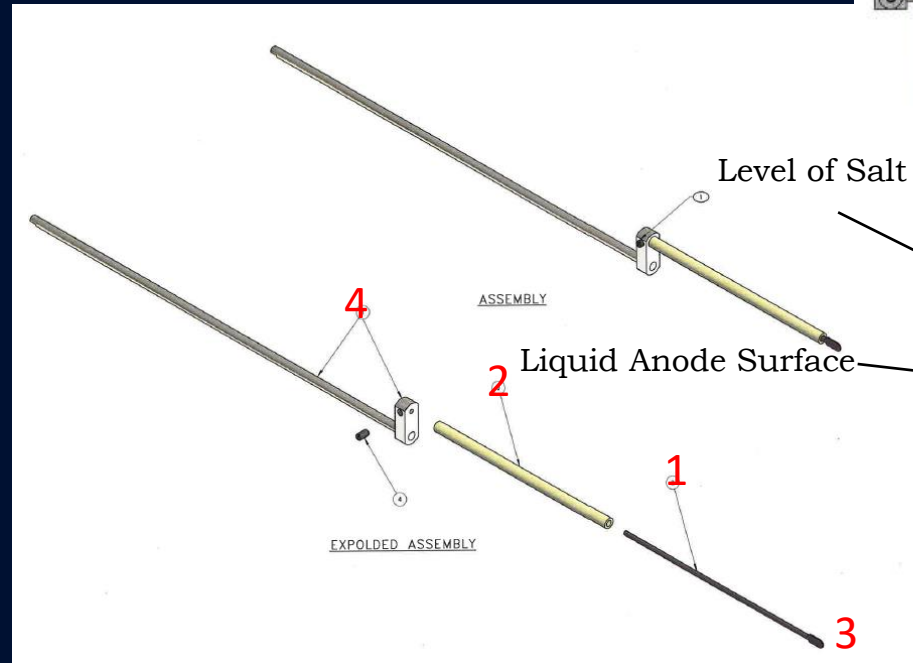
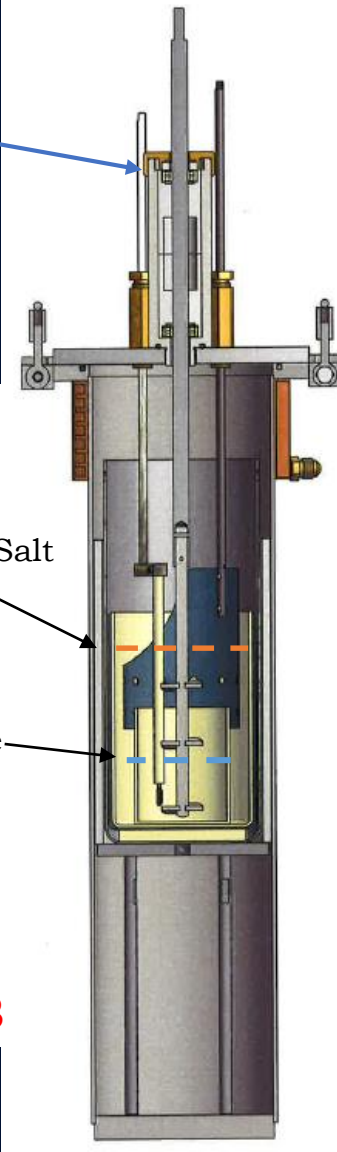
(1) **Tungsten:** electrically conductive, will not oxidize significantly under applied loads (~20A, 2V), refractory metal resistant to Pu corrosion.

(2) **Magnesia Sleeve:** electrically insulates and protects electrode from electrolyte, same material as crucible, resistant to Pu/molten salt corrosion.

(3) **Paddle Tip:** electrical connection to liquid anode pool, prevents sleeve from falling off.

(4) **Dog Leg:** holds tungsten rod, sits inside furnace, passes current to tungsten, enables positioning rod within crucible cup.

Current applied here

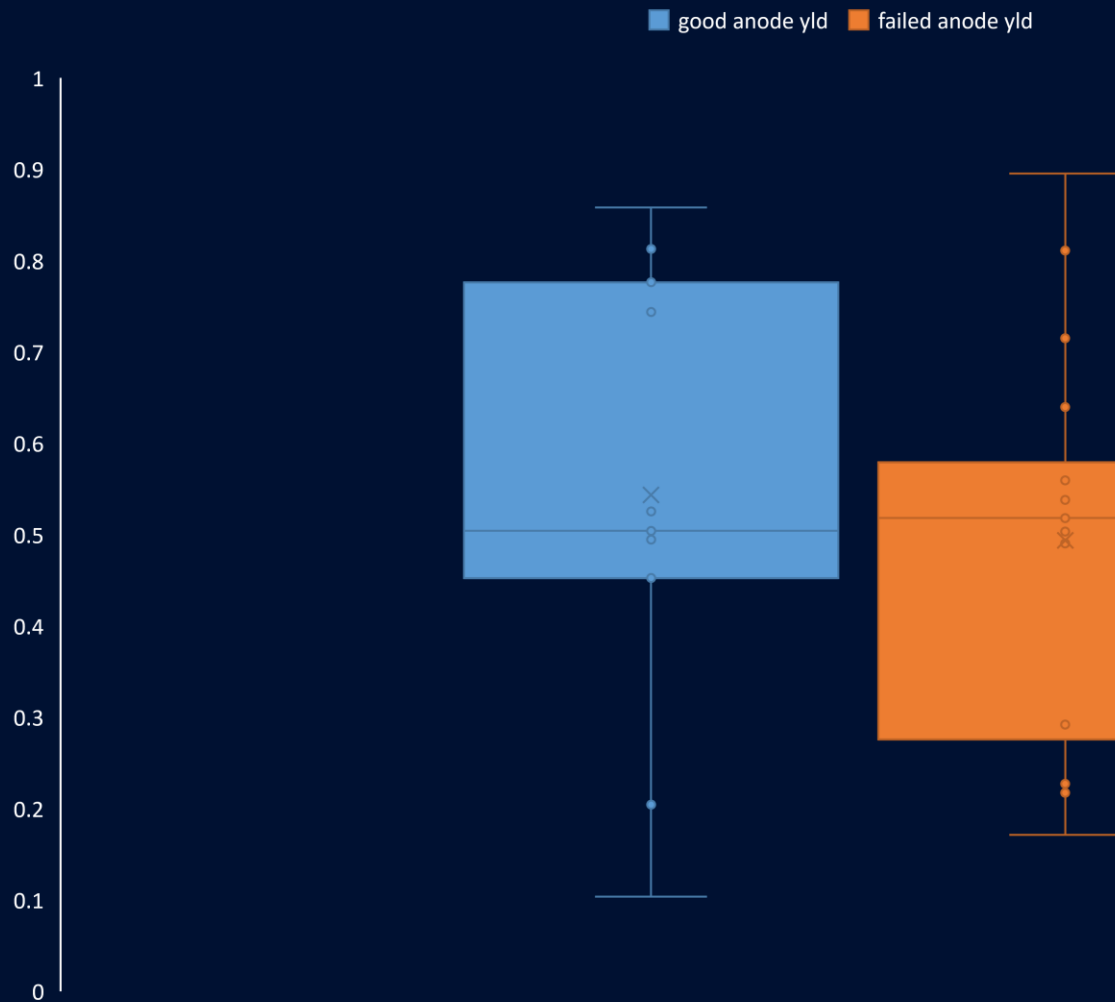
2021 yield failed vs good anodes

T-Tests

t-Test: Two-Sample Assuming Unequal Variances		
	good anode yld	bad anode yld
Mean	0.543413164	0.493556767
Variance	0.058828388	0.041601097
Observations	11	18
Hypothesized Mean Difference	0	
df	18	
t Stat	0.569677385	
P(T<=t) one-tail	0.287968999	
t Critical one-tail	1.734063607	
P(T<=t) two-tail	0.575937999	
t Critical two-tail	2.10092204	
t-Test: Two-Sample Assuming Equal Variances		
	good anode yld	bad anode yld
Mean	0.543413164	0.493556767
Variance	0.058828388	0.041601097
Observations	11	18
Pooled Variance	0.047981575	
Hypothesized Mean Difference	0	
df	27	
t Stat	0.594726428	
P(T<=t) one-tail	0.27848898	
t Critical one-tail	1.703288446	
P(T<=t) two-tail	0.556977959	
t Critical two-tail	2.051830516

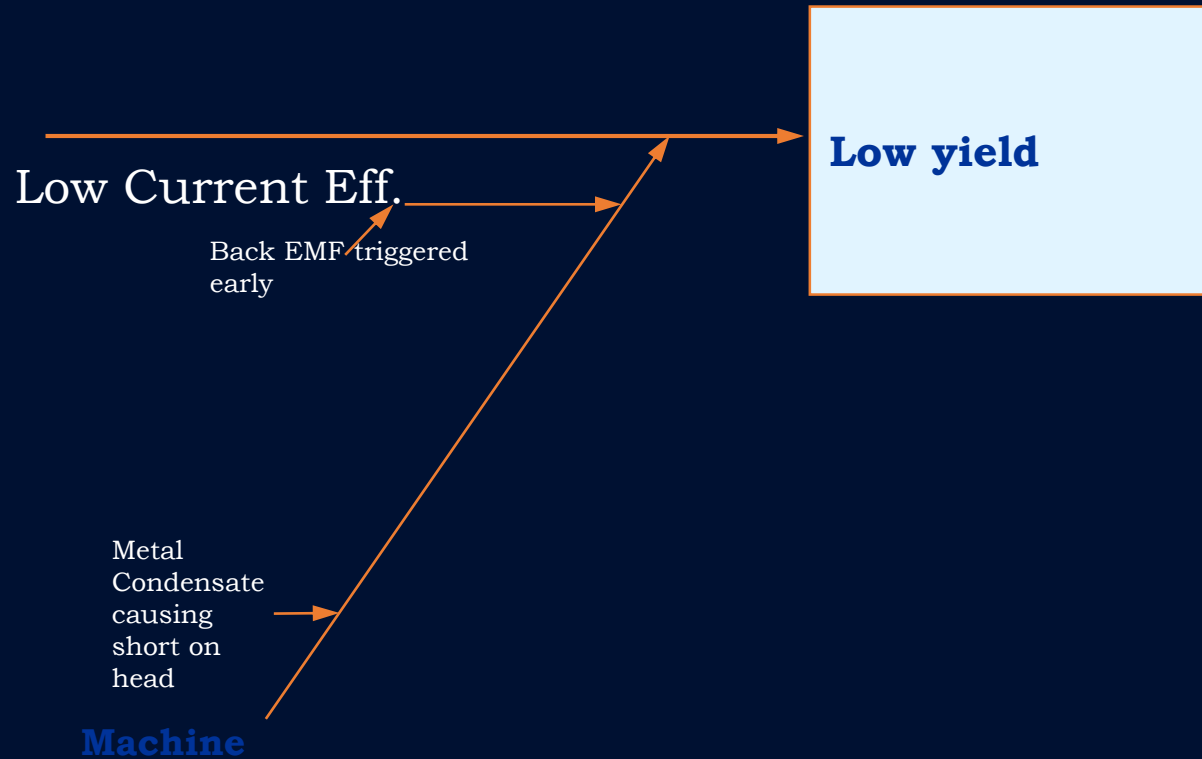
Machine

Problem

- Metal Condensate causing short on head
- Back EMF triggered early?
- Filing Anode too much

Test

- Unknown
- Raise back EMF threshold, get chemistry
- New experimental anode

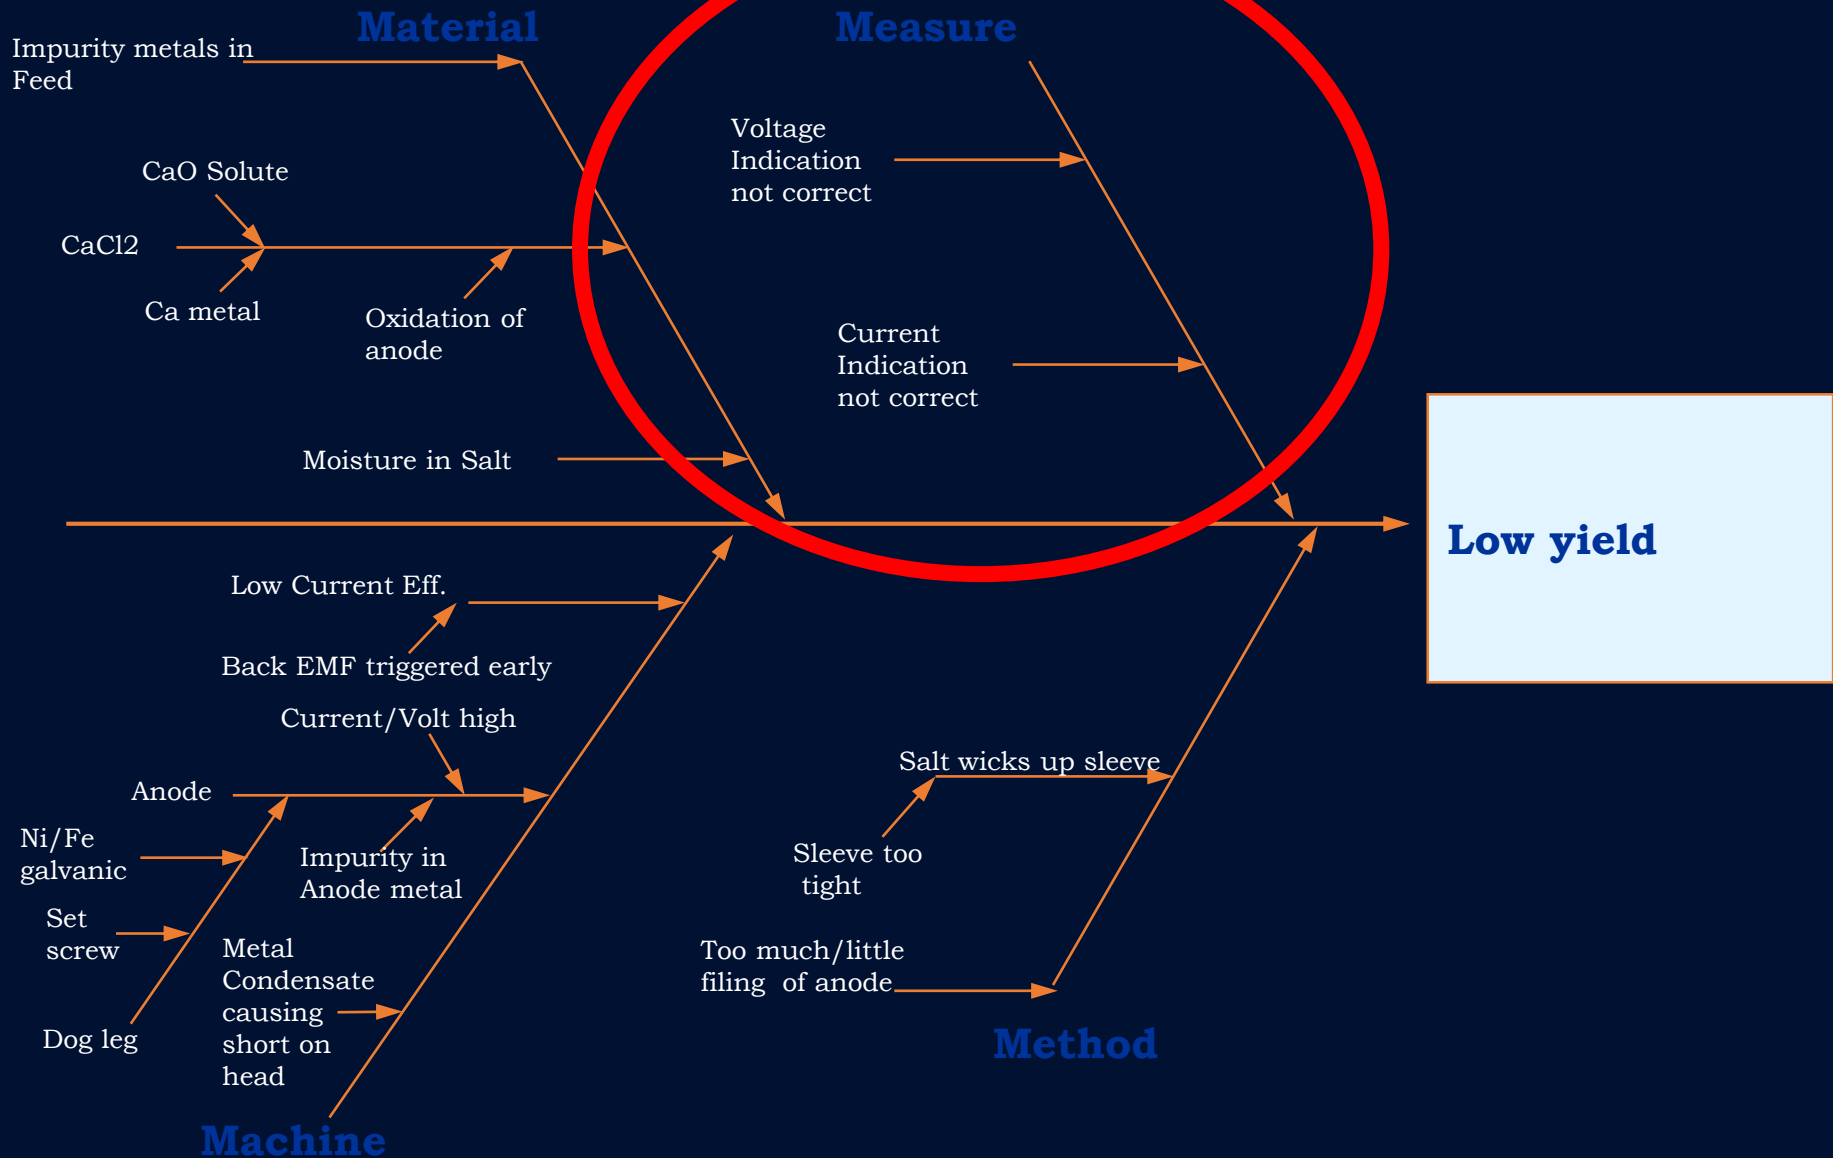
Measure

Problem

- Voltage Indication incorrect
- Current indication incorrect

Test

- Into multi-meter with alligator clips
- Use a current clamp on top of box

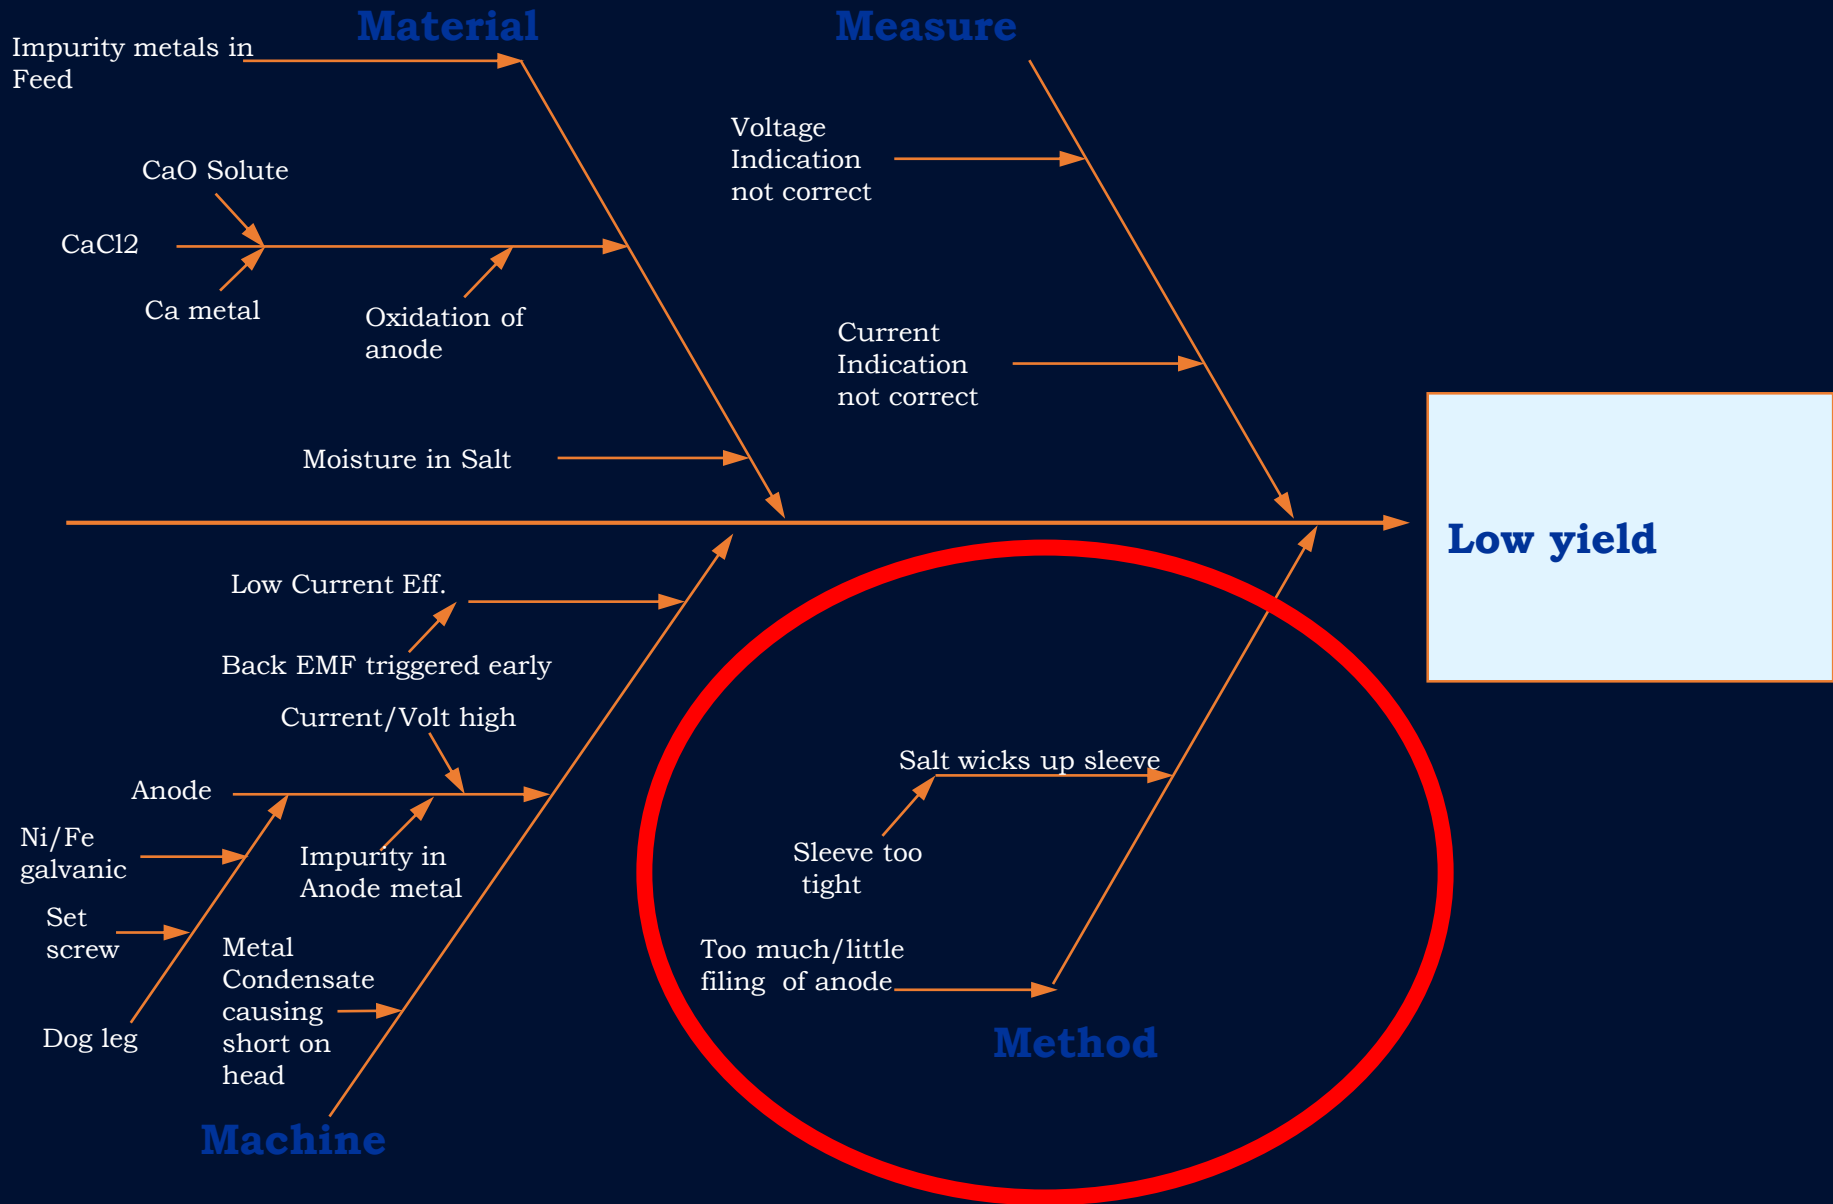
Method

Problem

- Sleeve is overtightened and salt wicks up sleeve and starts making contact with dog leg.

Test

- Have a slot gauge to ensure spacing

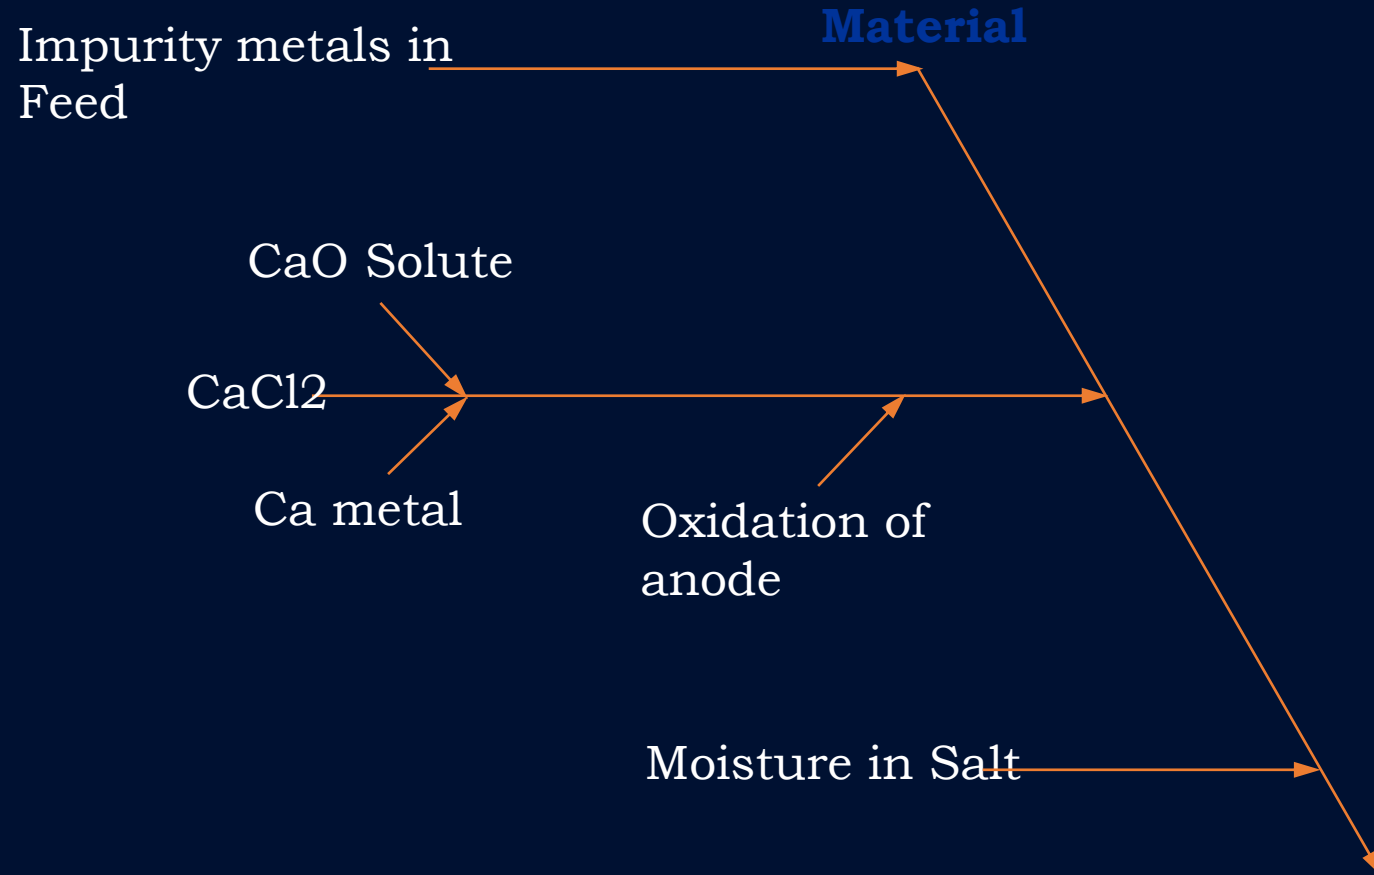
Material

Problem

- All issues related to CaCl_2
- Impurity in feed
- Moisture in salt
